Traffic Engineering and Highway Safety Bulletin 23-02 August 2023

TOP TEN ACTIVE VEHICLE BARRIER (AVB) ISSUES

TRANSPORTATION ENGINEERING AGENCY (TEA)

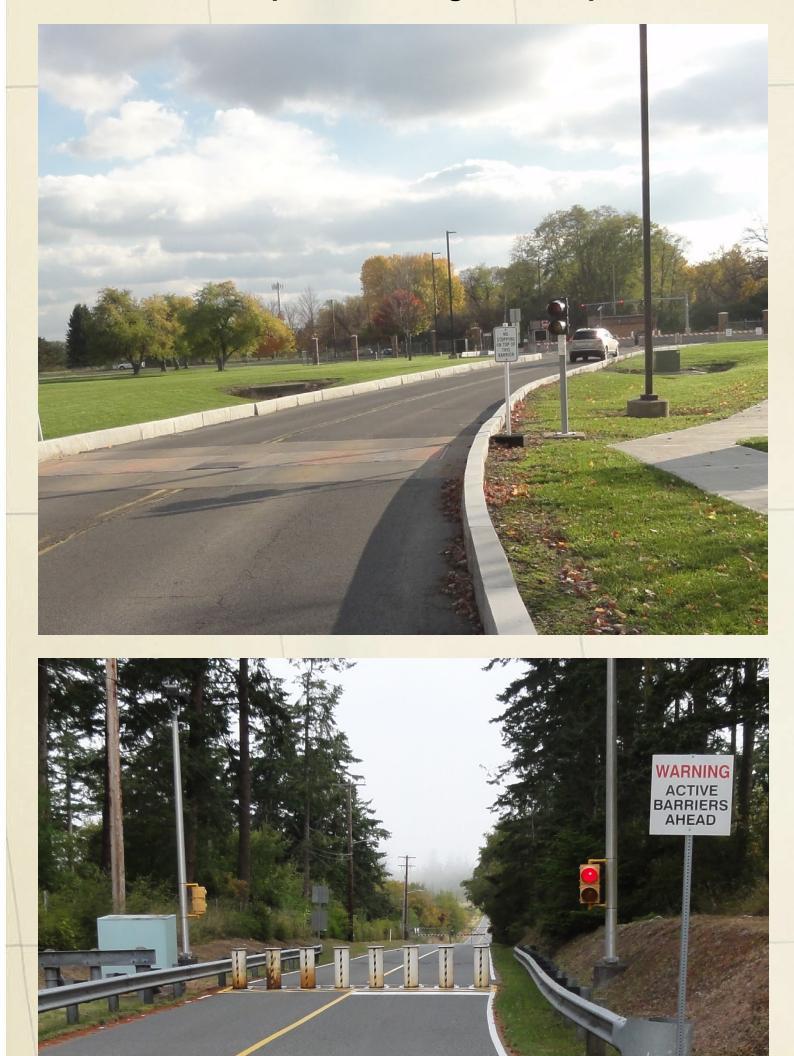
Non-Compliant AVB Signal Examples

Many existing signals are mounted too low (3-4 feet) and utilize the two-section traffic signal head instead of a threesection. Signals that are side mounted signals should be placed on overhead mast arms. These undersized signals, combined with the low mounting height, do not conform to the Manual on Uniform Traffic Control Devices (MUTCD) or the <u>DoD Supplement to the MUTCD</u>, and do not provide the correct signal visibility.

The following photos are examples of incorrectly installed side posts and signal heads. In both cases, the signals are mounted too low and utilize a two-section traffic signal head instead of a three-section signal head. These side mounted signals should have also been placed on an overhead mast arm.

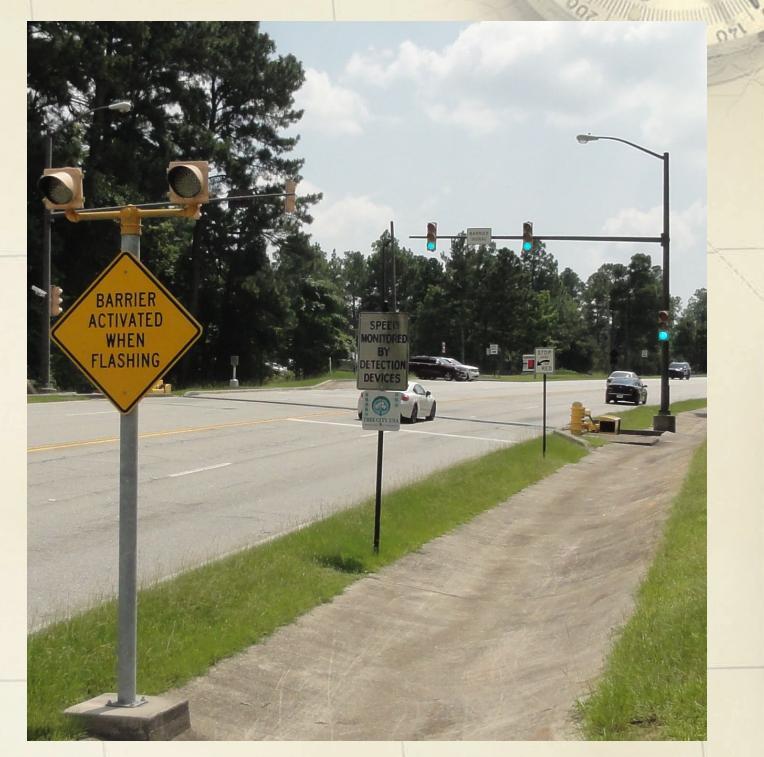
Example of Irrelevant Signing Approaching AVBs

TEA commonly observes sign clutter in the response zone. Sign clutter may consist of installation regulation signs, guide signs, or common and appropriate roadway signs such as speed limit signs. Installation regulation signs should not be installed in the gate area, especially in the response zone. Installation regulation signs are not traffic-related, and if used, should be located farther from the edge of the roadway to not detract from important signs. To avoid sign clutter within the AVB safety scheme, it is recommended to place guide and installation regulatory signs after the AVBs. This would also apply to marguis signing. The lights and changing messages for marquis signing can be distracting if it is in the response zone leading to the barriers. Traffic control signs used within the response zone should be placed an appropriate distance in advance of the AVBs.

Signing for the outbound direction is similar; signing should not conflict or obstruct the AVB safety scheme signing.

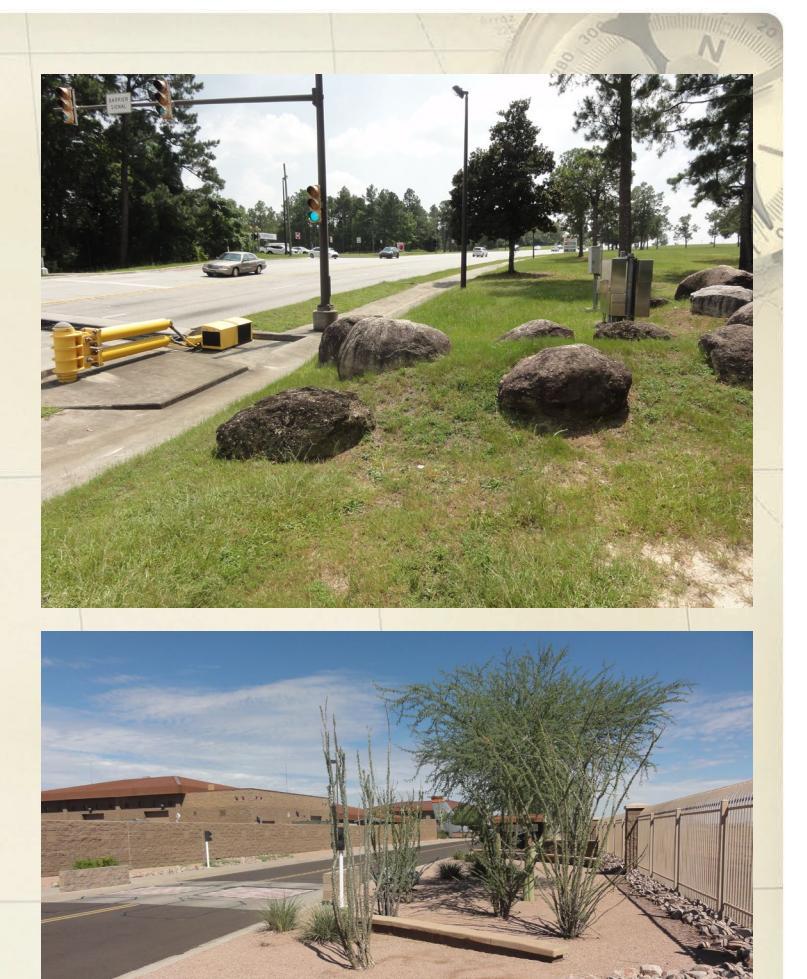
Gaps between the AVB and Passive Barrier Examples

The following photos show gaps in barrier. Large rocks are not considered acceptable as a passive barrier due to size, shape, weight, and composition variation. That aside, the gaps between the AVB and boulders is greater than 3 feet and can be breached by certain vehicles. The second photo also shows a gap next to the barrier. The low height wall extending from the barrier is not a compliant passive barrier, and it does not extend to the fence, resulting is a wide gap. The rocks in the foreground of the photo can be traveled over by the right vehicle.

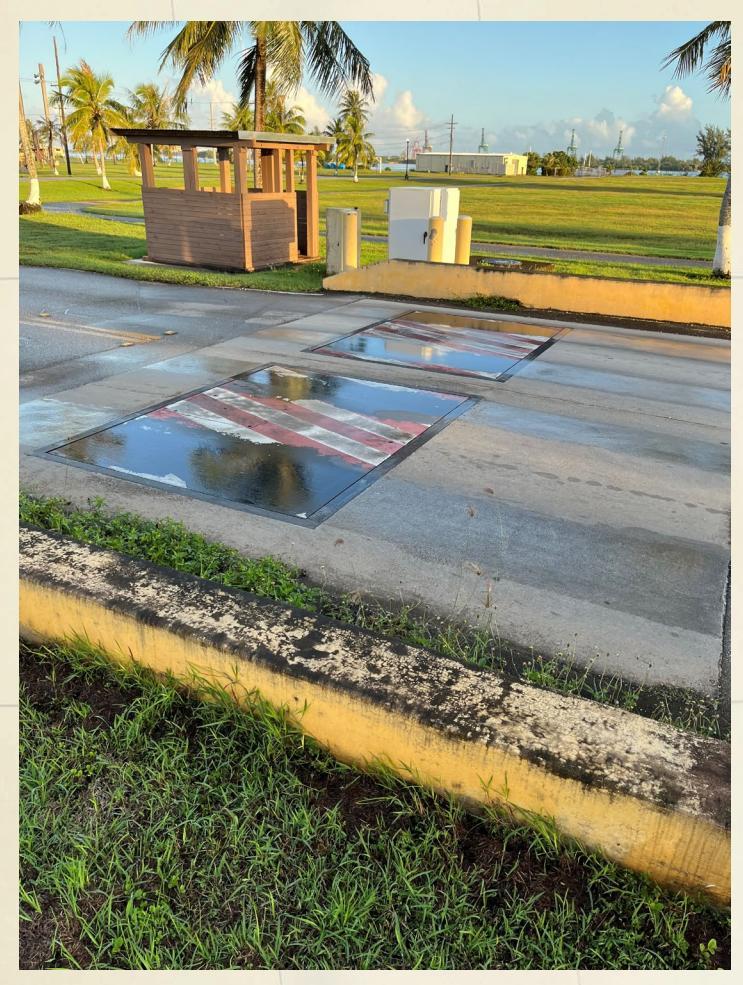
Wedge Barriers with Faded Paint.

Without visible paint, the barrier is not visible to outbound vehicles if activated
