Traffic Engineering and Highway Safety Bulletin 23-02 August 2023

TOP TEN ACTIVE VEHICLE BARRIER (AVB) ISSUES

TRANSPORTATION ENGINEERING AGENCY (TEA)

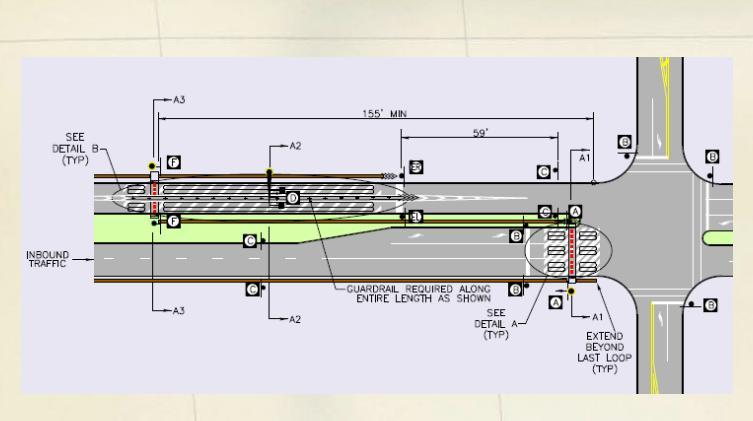
Outbound: Provide a minimum 155 feet between the barrier and the intersection. This is based on providing a sufficient distance approaching the barrier for all required signing and signals.

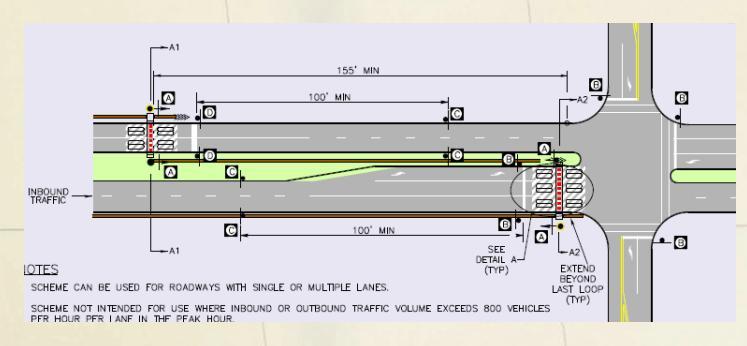
Inbound: If the barrier is within 200 feet of an intersection, and the midblock Stop Control Safety Scheme was intended, relocate the barrier on the inbound side to the intersection. It is not necessary that the inbound and outbound barriers be adjacent; they can be staggered if there is a median barrier with passive barrier between them.

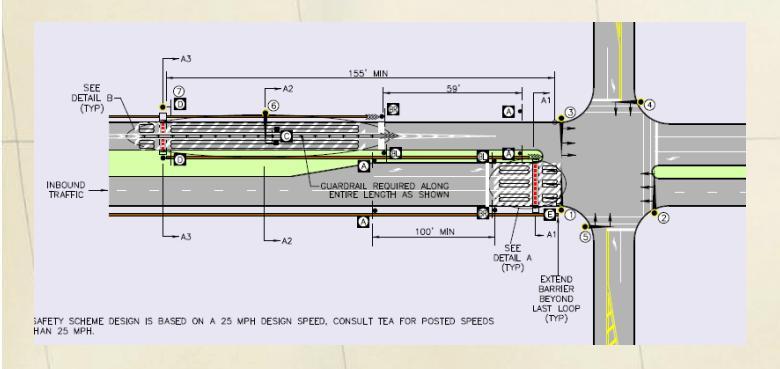
Inbound: If the barrier is within 300 feet of an intersection and a Hybrid Beacon Safety Scheme was intended, relocate the barrier on the inbound side to the intersection and use the Intersection Combination 9-Sec Traffic Signal/7 Sec Hybrid Beacon Safety Scheme.

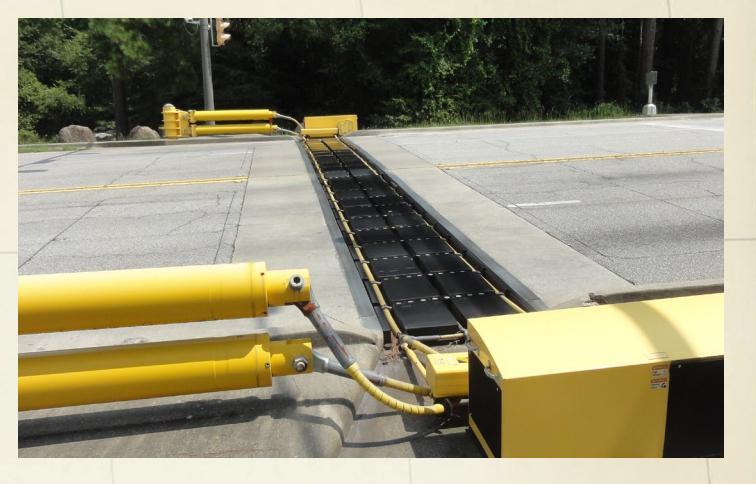
Loops Used at AVB

Detection loops are an important safety component to AVB operation. A detection loop is required to verify that the barrier is free of traffic traveling over it, and if so, allows the barrier to activate. If a vehicle is present on the loop, it will delay activation until the vehicle passes over the barrier. A loop is required both before and after the barrier to allow a buffer between the barrier activation and an innocent driver to clear the AVB. Detection loop widths are 6 feet, and the lengths will range from 6 feet to 76 feet, dependent on which AVB Safety Scheme is utilized. Loops installed by the barrier manufacturer are often too short, often 3 to 4 feet at the barrier, are not placed at the correct location from the AVB or do not have an exiting detection loop (after the AVB).

- ☑ 0-Second Full Containment Safety Scheme: 10foot loop at the stop line; 6-foot loop before and after the barrier.
- ☑ 5-Second Stop Control Safety Scheme: 6-foot loop before and after the barrier.
- 7-Second Hybrid Beacon Safety Scheme: 76-foot loop in advance of the barrier and 6-foot loop after the barrier.
- 7-Second High Efficiency Presence Detection Safety Scheme: 8-foot loop in advance of the stop bar, 34-foot loop approaching the barrier, and 6foot loop after the barrier.
- 9-Second Hybrid Beacon Safety Scheme: 20-foot loop in advance of the barrier and 6-foot loop after the barrier.
