Traffic Engineering and Highway Safety Bulletin 22-03 June 2022

## **TOP 10 ROAD SAFETY ISSUES**

#### TRANSPORTATION ENGINEERING AGENCY (TEA)

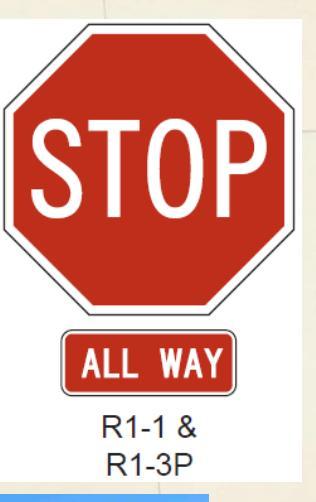
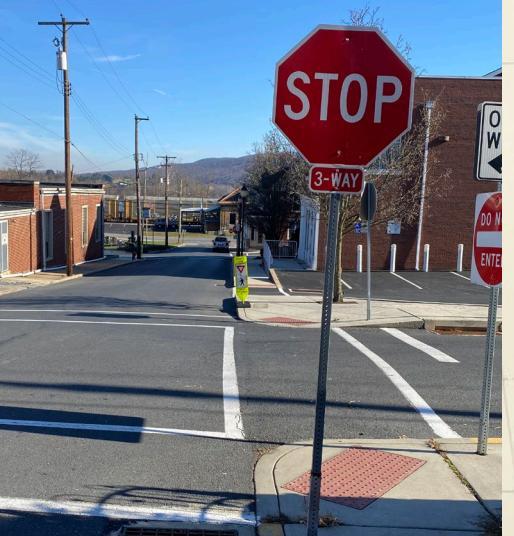
Use of an Obsolete 3-Way Plaque (File Photo)

The Manual on Uniform Traffic Control Devices (MUTCD) requires an ALL WAY plaque be mounted below each STOP sign at intersections where all approaches stop. There are two commonly occurring issues associated with this requirement: simply lacking the plaque at an all way stop controlled intersection and using an obsolete plaque indicating the number of legs which stop. Prior to the current 2009 MUTCD edition, plaques indicating the corresponding number of approach legs were allowed. Under that permission, it was not prohibited to post 2-WAY plaques beneath the STOP signs at a two-way stop-controlled intersection. Since most plaques were used at all way stop controlled intersections, they were

misinterpreted when used at two-way stop-controlled intersections. Drivers would see the sign, not necessarily read or misinterpret it, and upon expecting the conflicting approaches to also stop, would proceed into the path of an oncoming vehicle.

Per the MUTCD, the size of the ALL WAY placard is 18" x 6" when used with a 30" x 30" or 36" x 36" STOP sign, or 30" x 12" when used with a 48" x 48" STOP sign.

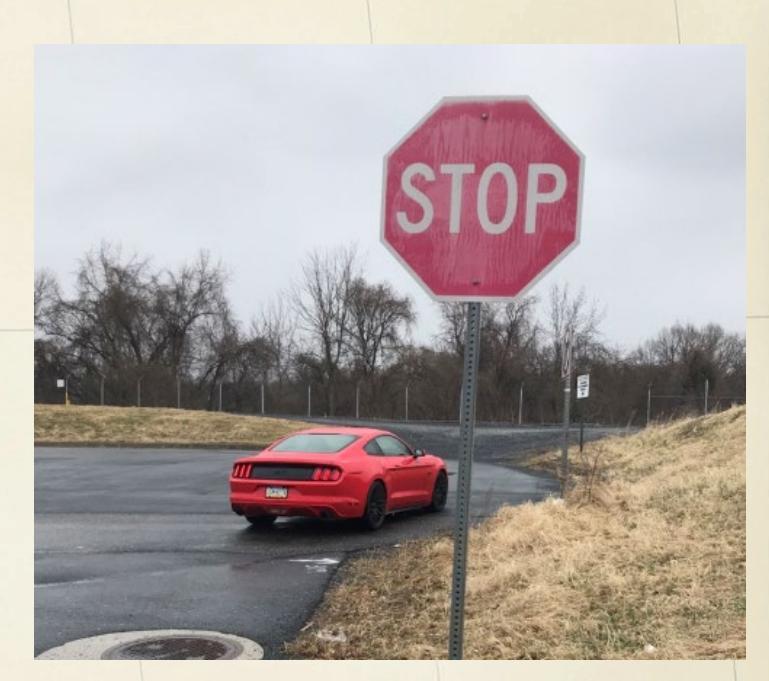
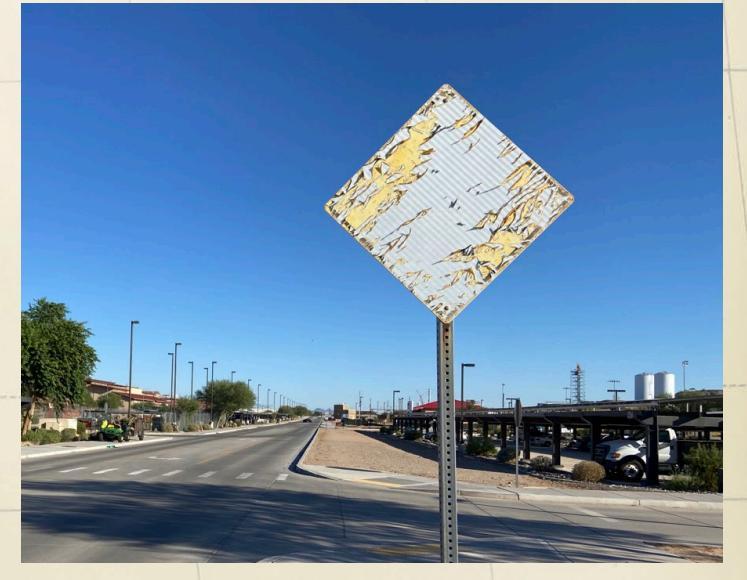
Faded Signs (File Photos)

Faded signs are a frequent safety problem on military installations. Faded signs lack a recognizable message, thereby not providing motorists with information critical to the driving task. This lack of critical information can have dangerous consequences for motorists. The cost of replacing a sign is considerably less than the consequences of a crash and drivers should not have to rely upon guessing or sign shape to interpret its message.

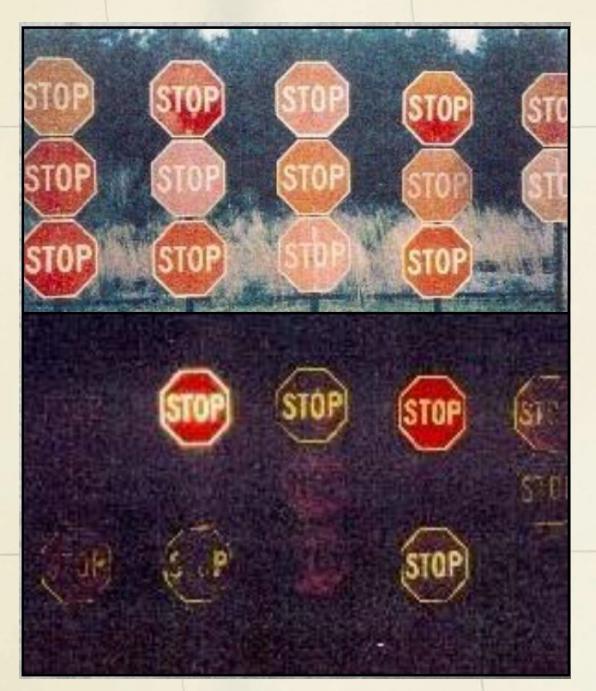
#### Daytime Versus Nighttime Sign Comparison

Along with the need for daytime visibility, retroreflective signing is critical for nighttime visibility. Signing with inadequate retroreflectivity lacks nighttime visibility while a faded sign lacks daytime visibility. Type III or better sheeting material is recommended by TEA since lesser grade sheeting barely meets the MUTCD retroreflectivity requirements. Just because a sign is visible by day does not mean it has adequate nighttime retroreflectivity.

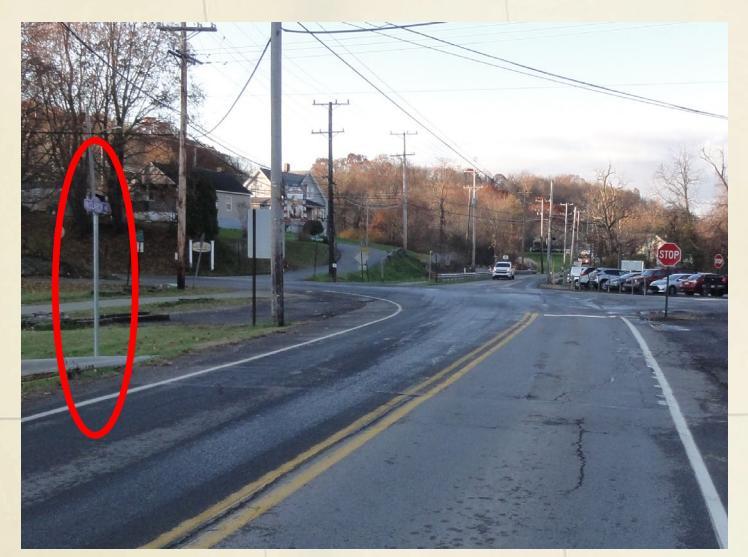
#### Street Name Sign Located too Far from Intersection to be Visible from Cross Street (File Photo)

At minor intersections, one street name sign facing each approach is permissible; but at major unsignalized intersections and in business or commercial areas, install street name signs on diagonally opposite corners. The signs are normally double-sided so that they can be read in both directions of travel.

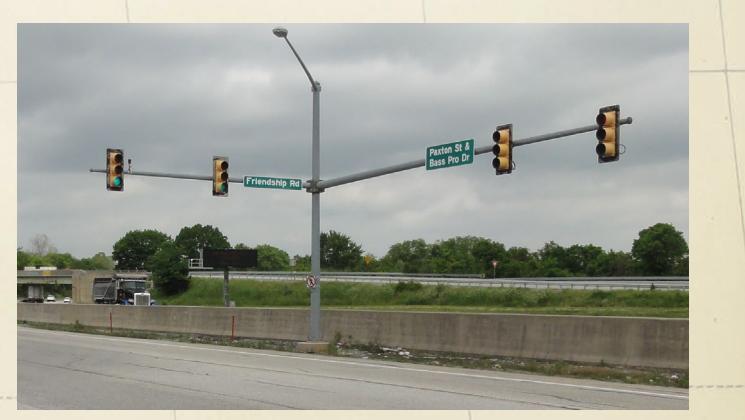
**Overhead Street Name Signs (File Photo)**

Special hardware is available to mount the sign panels from their bottom edge so that both sides of the sign are clearly visible to approaching drivers. At signalized intersections, it is recommended to mount street name signs overhead on the signal mast arms or span wire near the signal heads to maximize visibility.

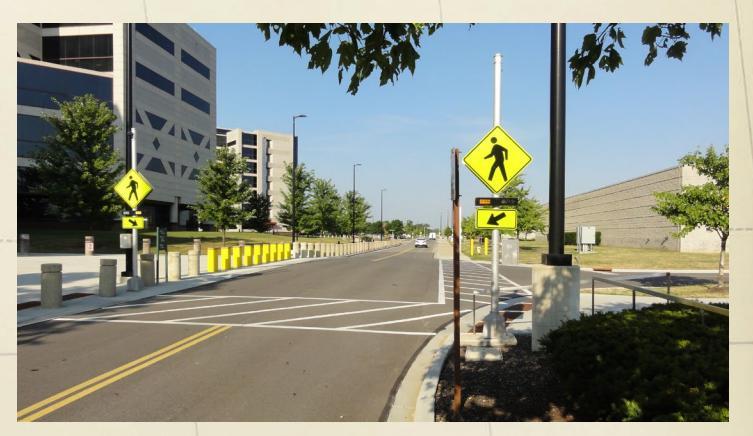
Uncontrolled Crosswalk Treatment Example (File Photo)

After determination is made that a crosswalk is warranted, TEA's Addendum to SDDCTEA Pamphlet 55-17, Crosswalk Warrant and Guidelines provides enhancements that should be added when implemented.

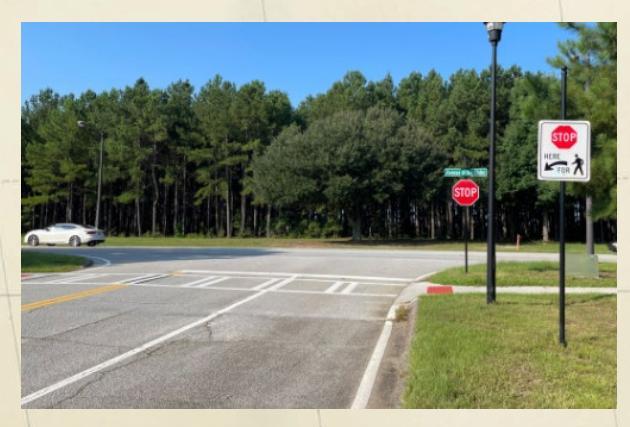
**Crosswalk in advance of Stop Line (File Photo)**

The crosswalk in the above photo is especially problematic because the Stop Here for Pedestrians sign is an incorrect attempt to provide traffic control for the crosswalk but makes the STOP sign message at the intersection ambiguous. Is a stop at the intersection necessary if there is no pedestrian in the crosswalk?

Ideally, mitigation for this condition is to simply relocate the sidewalk approaching the intersection. It is possible to simply relocate the stop line in advance of the crosswalk as long as the ending location is not too far from the roadway. If the distance is significant, drivers tend to stop at the location they believe is appropriate for seeing traffic at the intersection.

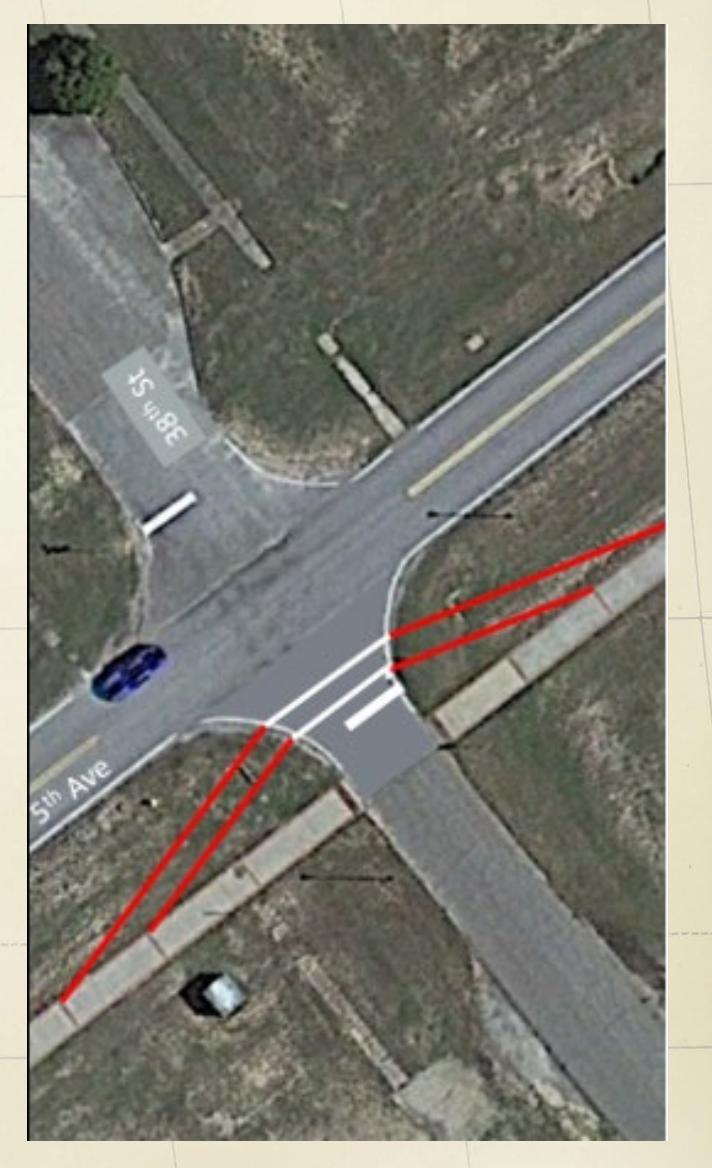
The graphic below shows an example of the preferred treatment where the sidewalk connection is relocated closer to the intersection, allowing the crosswalk to be in advance of the stop line.

Sidewalk Relocation Closer to Intersection Image Source: Installation aerial imagery

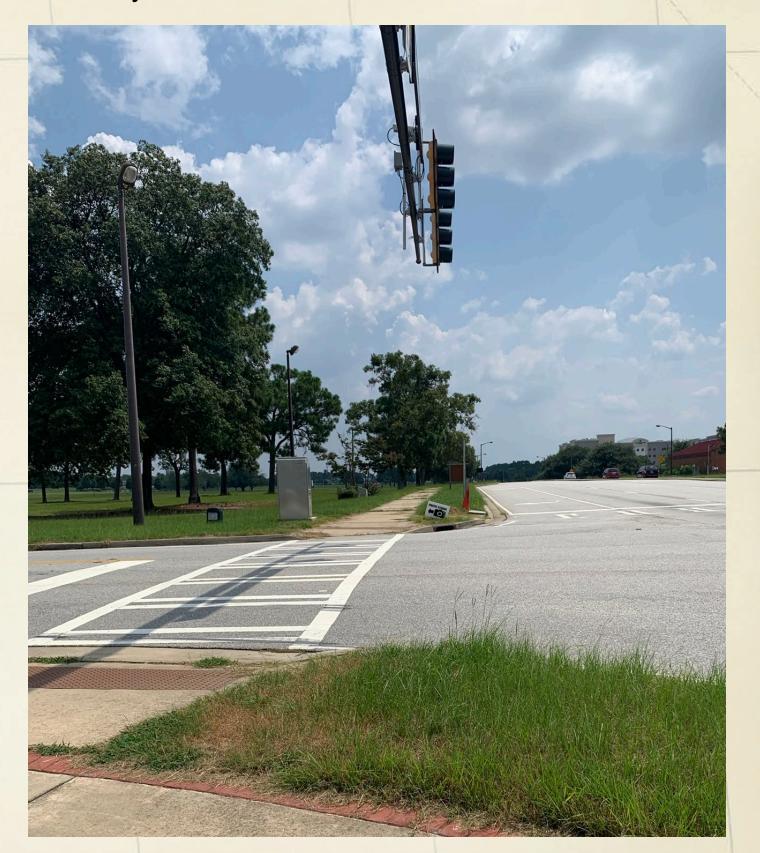
Crosswalk at Signal Lacking Pedestrian Accommodations (File Photo)

As pedestrians have an equal right to access and to use the roadway, the design of a signalized intersection should include accommodations for this mode of travel. When there is evidence of even light pedestrian demand along a roadway, there will likely be some pedestrian demand through the intersections - - pedestrians are expected at intersections so motorists are more aware of their presence. Crosswalks located at signalized intersections do not need to meet minimum pedestrian crossing warrants, as they would with crossings at uncontrolled locations. It is preferred to have pedestrians cross at intersections. When an intersection is signalized, it is generally safer for pedestrians since vehicular traffic is controlled and pedestrians can cross with signal indications. The WALK and DONT WALK indications are critical in providing pedestrians with guidance for when to cross, as well as providing adequate time for their crossing of the road when activated.

When designing a new signal, the cost of pedestrian accommodations is typically limited to the cost of pedestrian signal heads and pushbuttons, along with wiring leading from these to the signal controller. Occasionally, with certain geometric conditions, special poles are needed for pushbuttons and signal heads apart from the poles used for the mast arms. The cost of mast arms or strain poles for span wires is significant, as is the controller and cabinet assembly. In comparison, the cost for pedestrian accommodations is minimal and a minor cost overall. However, as with any component, they must be maintained and kept in working order. A nonfunctional pushbutton can be replaced quite easily; and, with LEDs common for signal indications, the lifespan of the signal indications is long. It is also to the drivers' advantage to have functional and properly timed pedestrian accommodations. Calculated minimum pedestrian crossing times must be provided at signals, which varies by intersection width. If the required time for the vehicular phases is less than the required time for pedestrians to cross, the complete pedestrian time is only provided when the pushbutton is actuated. Therefore, with no pedestrian demand, no unnecessary extra green time is provided, and the signal operates more efficiently for traffic conditions.

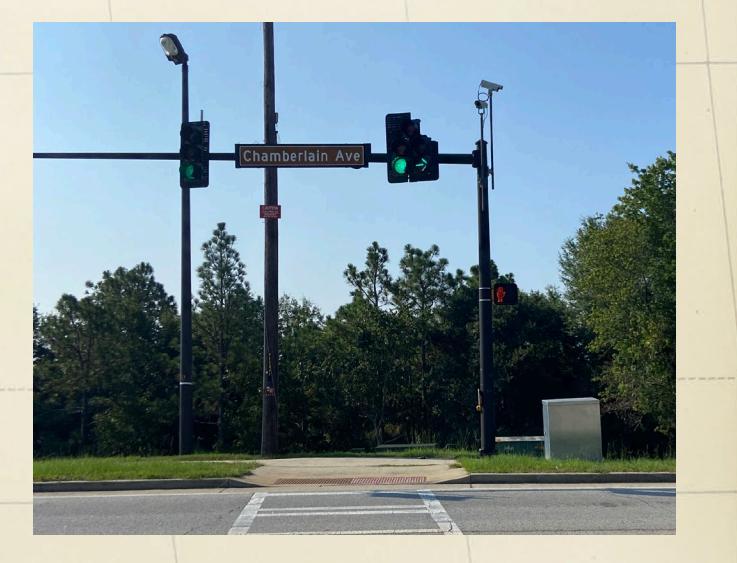
Traffic Signal with Broken Backplates and Heads out of Alignment (File Photo)

- Poor Maintenance. Signals must be properly maintained to operate properly. Signal indications not functioning, such as burned-out indications, are a clear sign of the need for maintenance. Signal wires dangling from the span wire or mast arm, signal attachment hardware becoming loose, or signal equipment in need of repair after being hit by a vehicle are all clear signs of maintenance needs.

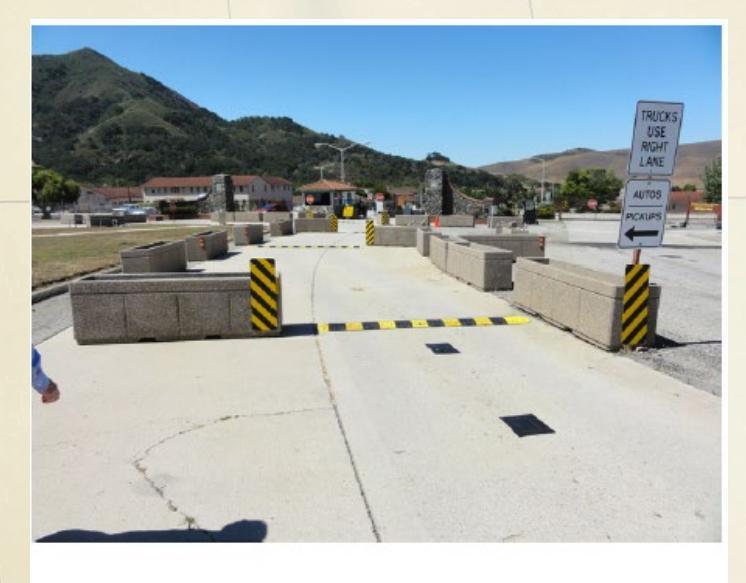
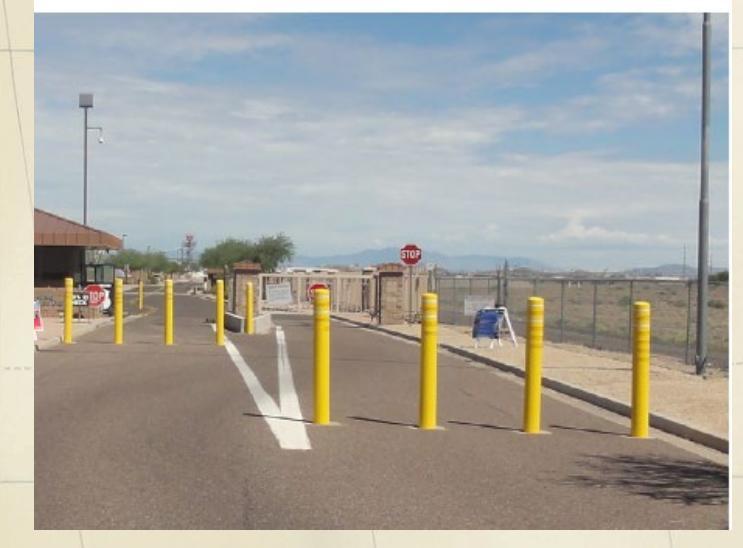
Concrete Barriers (Top) and Bollards (Bottom) [File Photos]

Entry control facilities (ECFs) are sized to have sufficient inbound ID check lanes that can accommodate morning peak period traffic. After the morning peak period, the full capacity is typically no longer needed and lanes can be closed. It is common for chicanes to be used to close one lane of a two-lane roadway through ECFs. The benefit is that doing so adds curvature that forces traffic to slow as it travels through the ECF approach; however, these chicanes are often incorrectly installed. Barriers or other blunt ends used for closures may lack delineation and provide little guidance to the motorist.

TEA discourages the use of blunt objects in roadways to close lanes because of the risk to motorists. Recognizing the security needs, if used, chicanes must have adequate spacing and delineation.

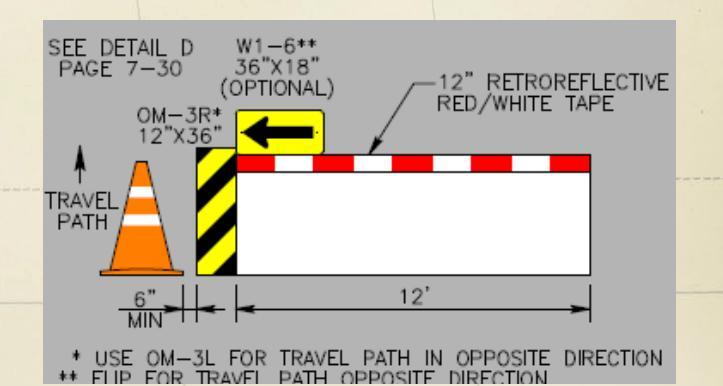
Barrier Delineation Detail excerpt from SDDCTEA Pamphlet 55-15. See 55-15 for complete detail.

If used, chicanes require proper traffic control to alert motorists of the condition. Proper delineation of barrier placements is critical to increase traffic safety and avoid operational conflicts. Red and white retroreflective markings (such as tape) must be installed on the barrier to improve delineation, though the specific type of material used will vary by type of barrier. In addition, chicanes need appropriate advance warning signs, and the travel paths through the chicane must be delineated using traffic cones and the adjacent edge of the barrier delineated with a black and yellow object marker (or tape, depending on barrier type).

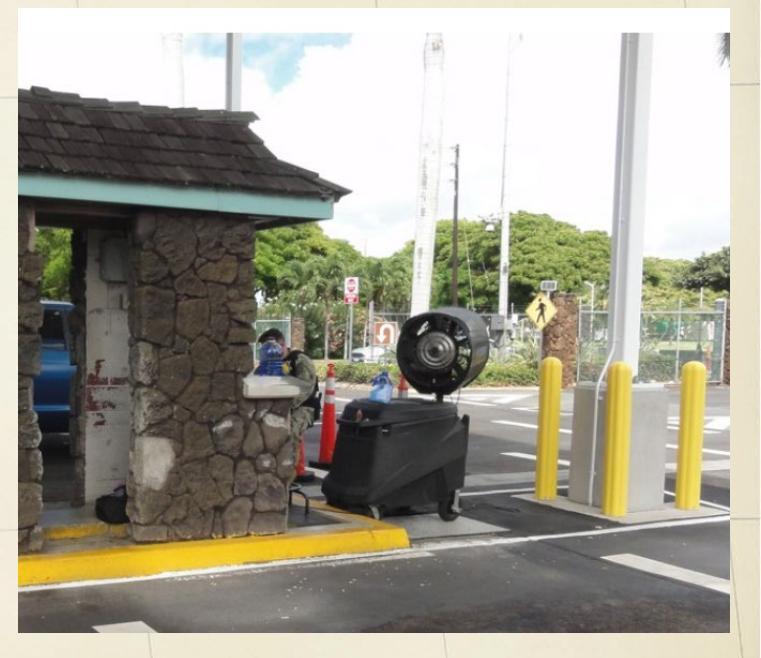
Bollards Protecting Light Pole are Additional Fixed Objects (File Photo)

Fixed objects should not be located within the roadway clear zone. Roadway barriers should only be used when the consequences of running off the road are more severe than the consequences of hitting the barrier. Many of TEA's studies have often observed instances where bollards are used to protect other fixed objects, such as fire hydrants, gas mains, or raised junction boxes located next to the roadway. The bollards worsen the crash severity of the hazard.
